**CUYAHOGA RIVER, OHIO  
RESTORATION STUDY  
SUPPLEMENT REPORT  
TO THE  
THIRD INTERIM PRELIMINARY  
FEASIBILITY REPORT  
ON EROSION AND SEDIMENTATION**

U.S. ARMY CORPS OF ENGINEERS, BUFFALO DISTRICT  
1776 NIAGARA STREET  
BUFFALO, NEW YORK 14207

JUNE 1982

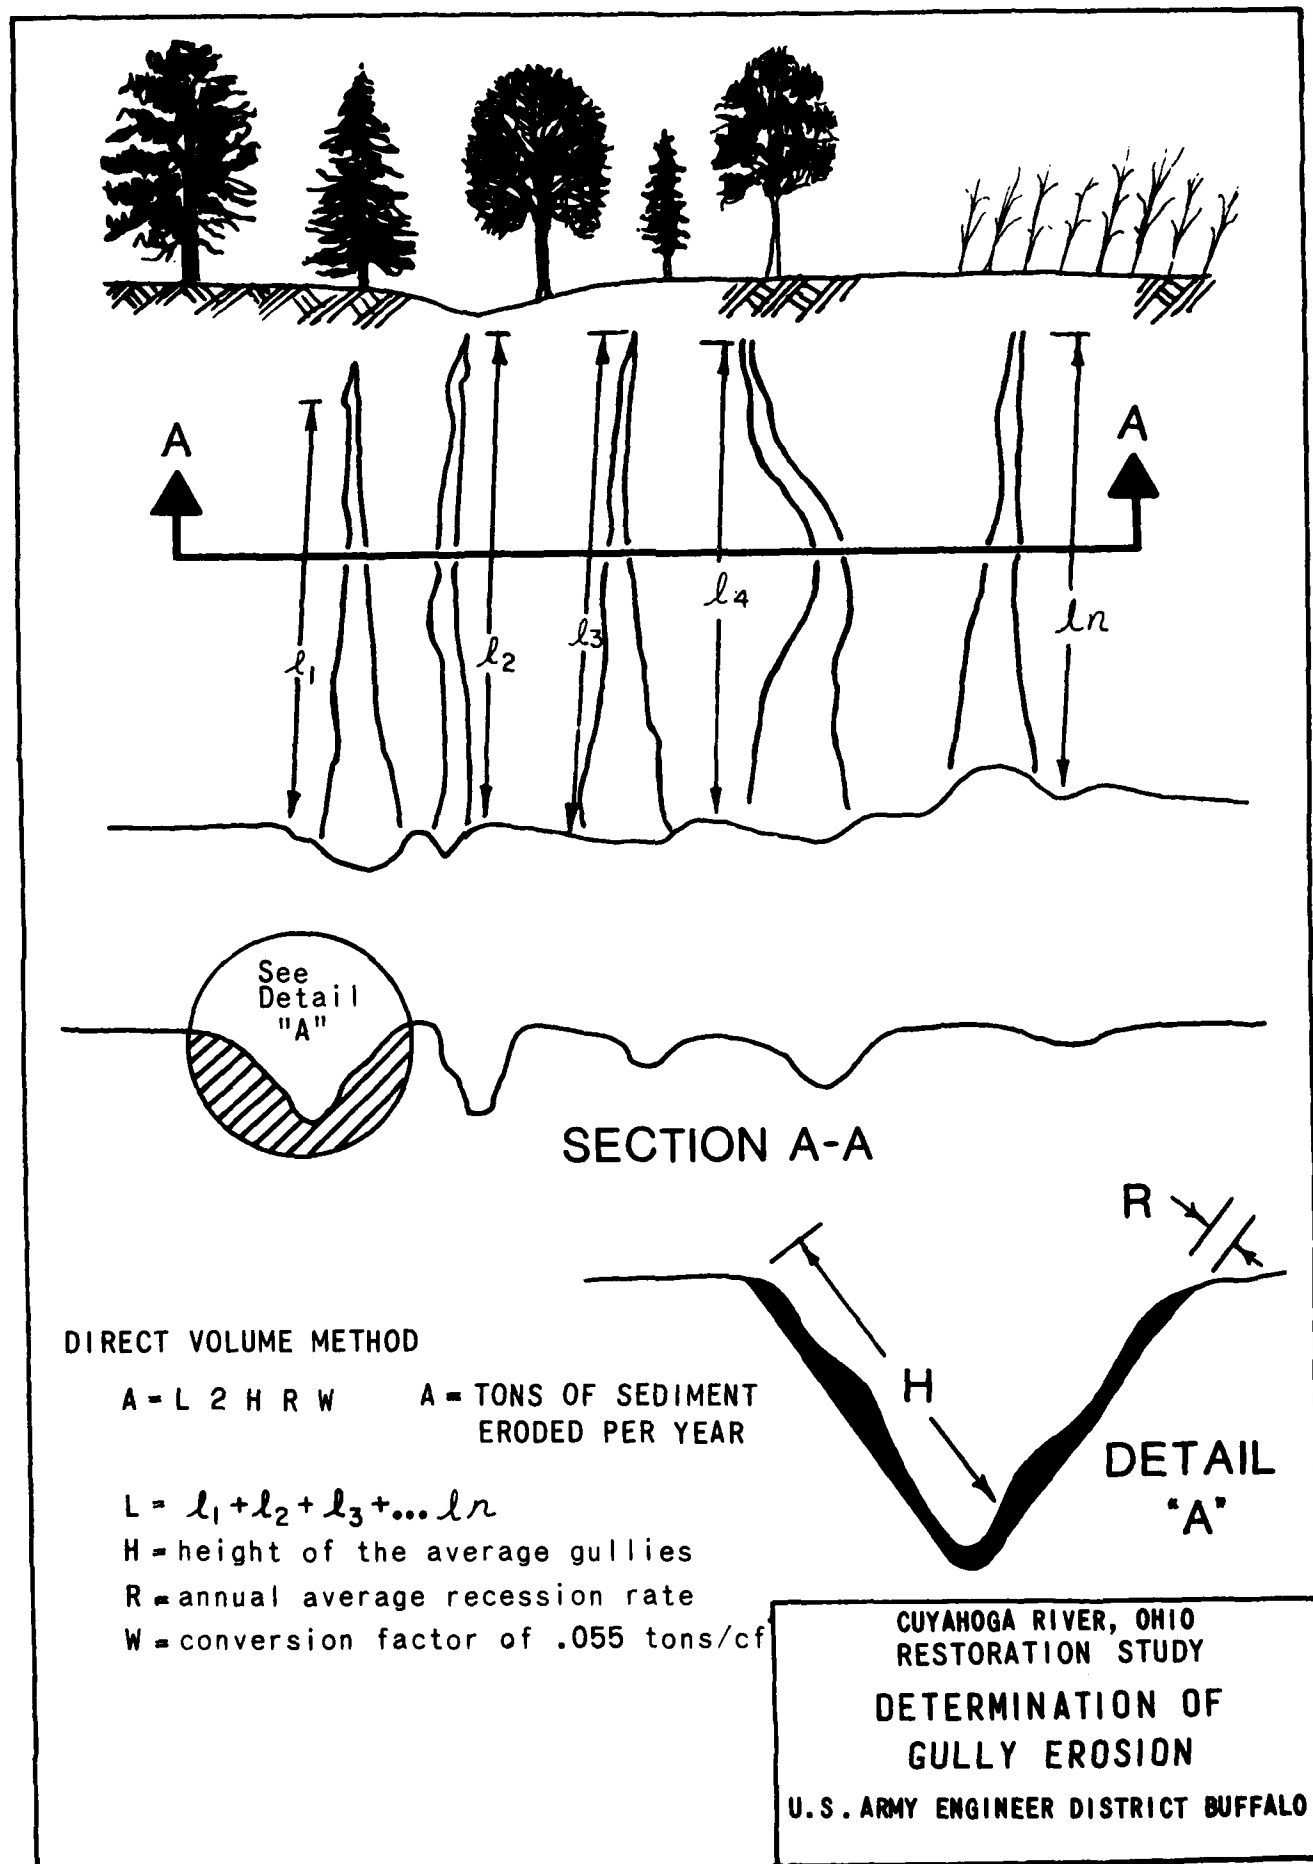
H is the average height of the gully side banks measured along the slope of those banks (see Figure 2).

R is the estimated average annual lateral recession rate of the gully (see Figure 2). This rate was determined in a 3 step process as follows:
